ERDC/CERL TR-00-24

## **Condition Assessment of Building 6237, Old Hospital Complex, Fort Carson, CO**

by Thomas R. Napier and Sheila A. McCarthy

August 2000

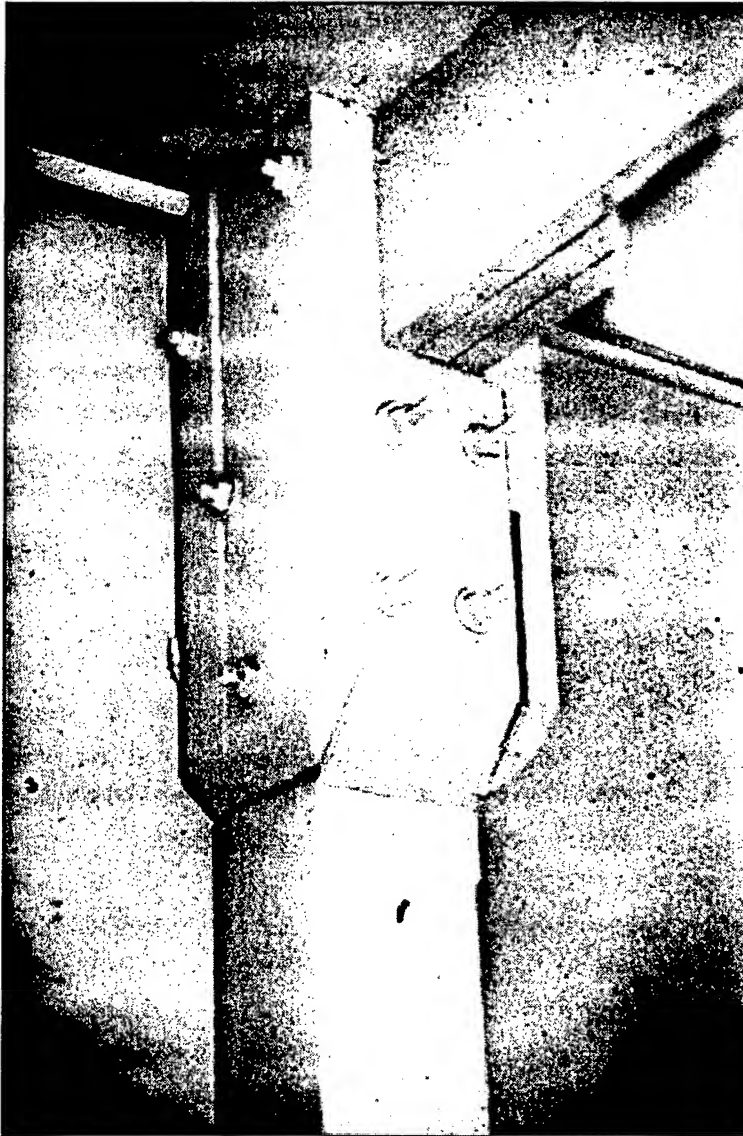
Figure 3-9. Beam pocket detail.

umn tops. A "beam pocket" is created by lapping 2 X 8s over the outer surfaces of the column; the beams are bolted through this beam pocket (Figure 3-9). Within the center core of the building, joists are carried by load-bearing 2 X 4 stud walls. Solid blocking between joists at the beams and bearing walls prevents overturning. There is one row of cross bridging within each span. Floor sheathing consists of nominal 1-in. boards placed diagonally across the joists.

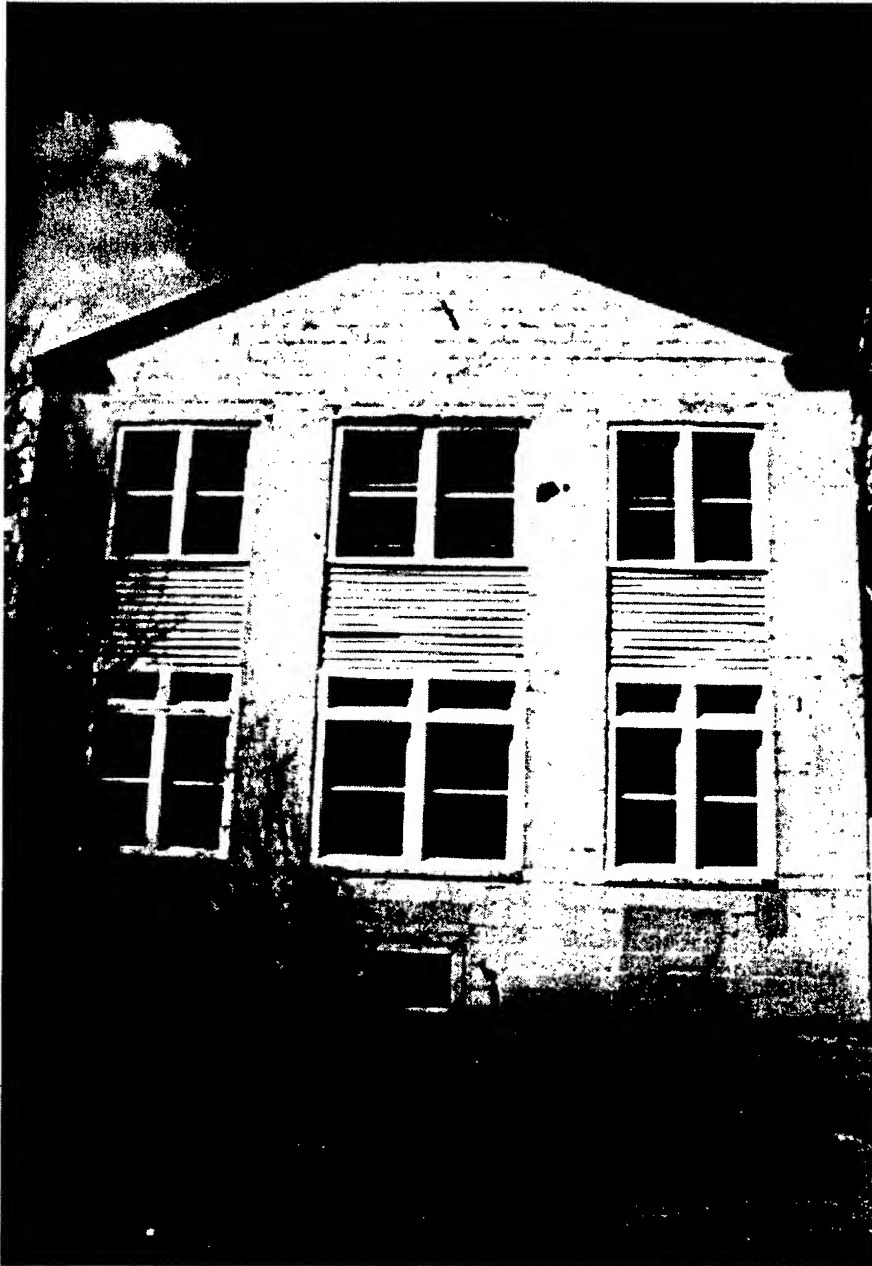
Figure 3-13. Gable end.

When viewed from the ground, each side of the gable appears to be quite flat and straight (Figure 3-13). The ridge appears to be flat and straight. No sagging was evident in any part of the roof. No further inspection was conducted from the outside.

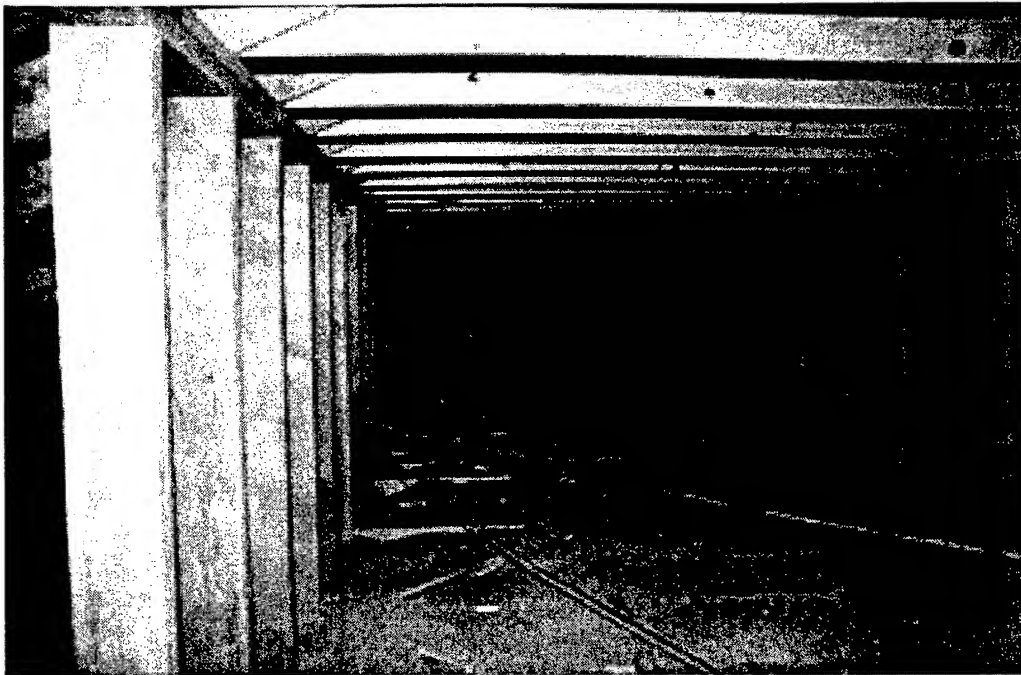
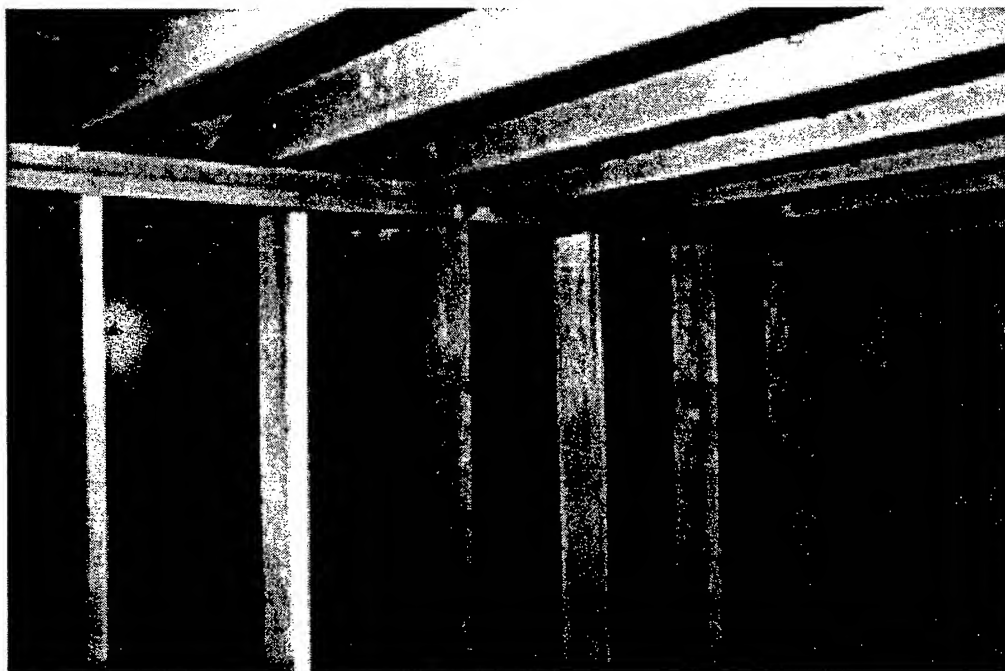
When viewed from below (from the attic spaces), the roof framing system appeared to be straight and true (Figures 3-14 and 3-15). Rafters were generally free from checks and knots. Pencil marks were observed, presumably made during construction, and members were still aligned with the marks. Structural members and sheathing appeared to be clean, with no evidence of water damage, or even staining. The bottom edges of rafters, in all locations, were aligned, with no saddles or sagging observable. There was no visible nail pulling, splitting, dislocation, or other sign of distress to suggest excessive uplifting at the eaves. Ridge boards were level and straight. The only irregularity observed in ridge boards was due to the slightly different dimensions of each individual 2 X 8. Knee walls were plumb, with no dislocation observed. Several ceiling joists were tested for level in several locations within each building bay. Some cracking was observed in ceiling surfaces (see "Ceiling Finishes" under Interior Construction). The joists above, however, were found to be level, with no signs of deflection or deformation.

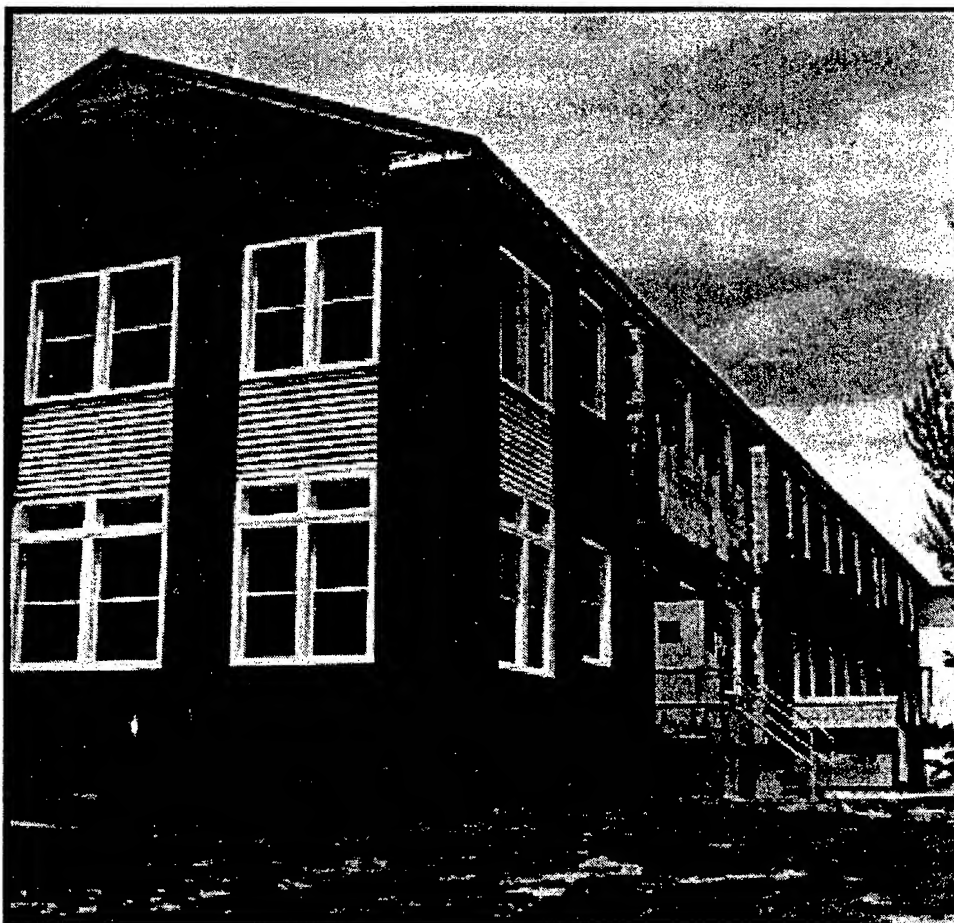
Figure 3-29. Original clapboard siding in stairwells.

One of the few architecturally defining features of the building is the panels between first and second floor windows at the stairwells. They are presently covered in vinyl siding. However, wood clapboard siding is present in similar buildings in the complex. This siding is framed into openings (similar to window framing) in the masonry wall (Point S and Figure 3-29). The vinyl would have to be removed and the original clapboard siding restored or replaced with a historically correct profile.

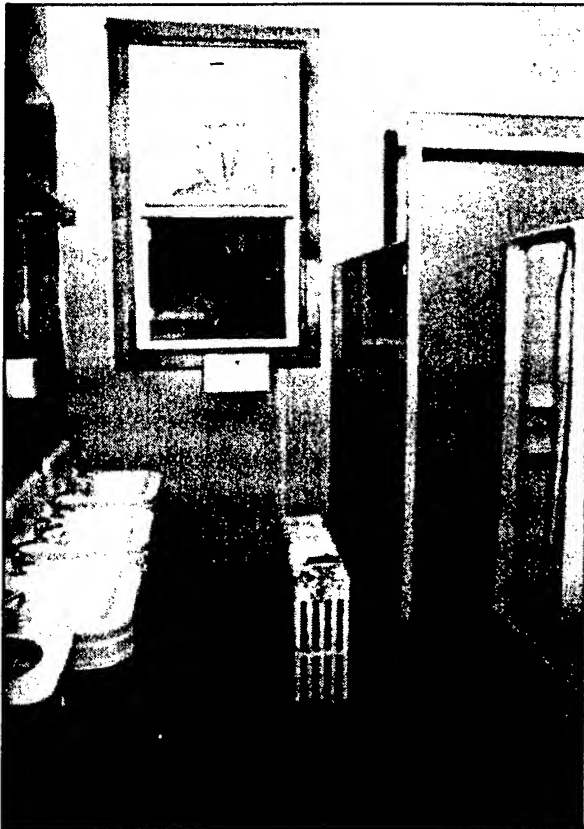
Figure 3-33. Group bathroom.

- Four group bathrooms (two on each floor), each consisting of three toilets, one urinal, four lavatories, and two showers (one of which was formerly a bathtub). All fixtures remain in place (Figure 3-33).
- Four lavatory rooms (two on each floor), each consisting of one bidet and one lavatory. Some bidet fixtures remain in place (Figure 3-34).
- Six private patient rooms (three on each floor), each having one toilet and one lavatory. Toilets and some lavatory fixtures remain in place (Figure 3-35).
- Four service closets (two on each floor), each having one janitor's sink, which remain in place (Figure 3-36).
